==== Shimadzu LabSolutions Analysis Report ====

Sample Name : BMS1166 1818314-88-3
 Vial# : 1-14
 Date Acquired : 2019/7/12 15:21:58
 Date Processed : 2019/7/12 15:32:09
 Data Filename : D:\DATA\20190708\BMS1166 1818314-88-3.lcd
 Method Filename : C:\LabSolutions\Data\Project1\ESI.lcm
 Batch Filename : D:\DATA\20190708\20190708.lcb

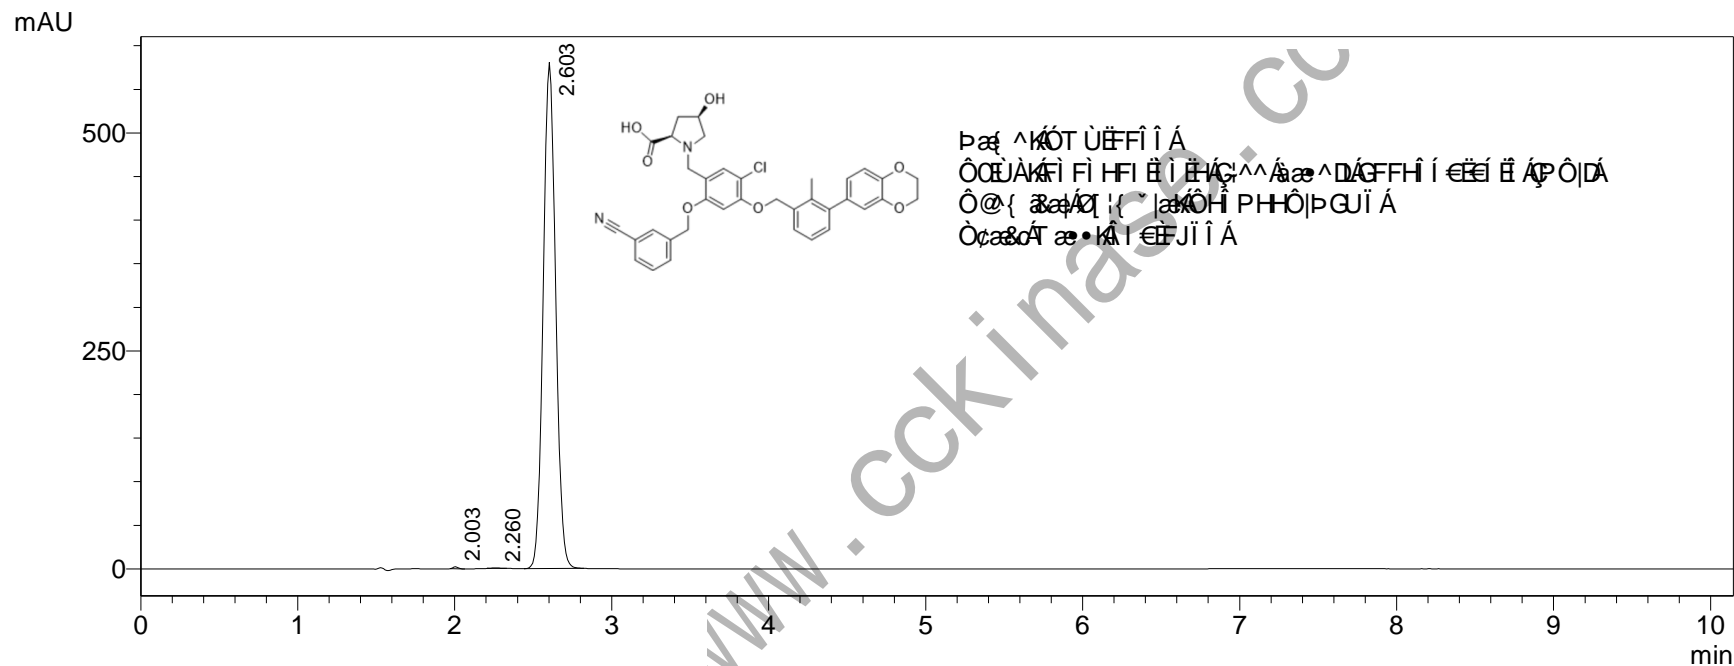
PDA Ch1 230nm

Peak#	Ret. Time	Height	Height%	Area	Area%	Name
1	2.003	2172	0.372	4884	0.153	
2	2.260	419	0.072	1575	0.049	
3	2.603	580674	99.556	3191404	99.798	
总计		583265	100.000	3197864	100.000

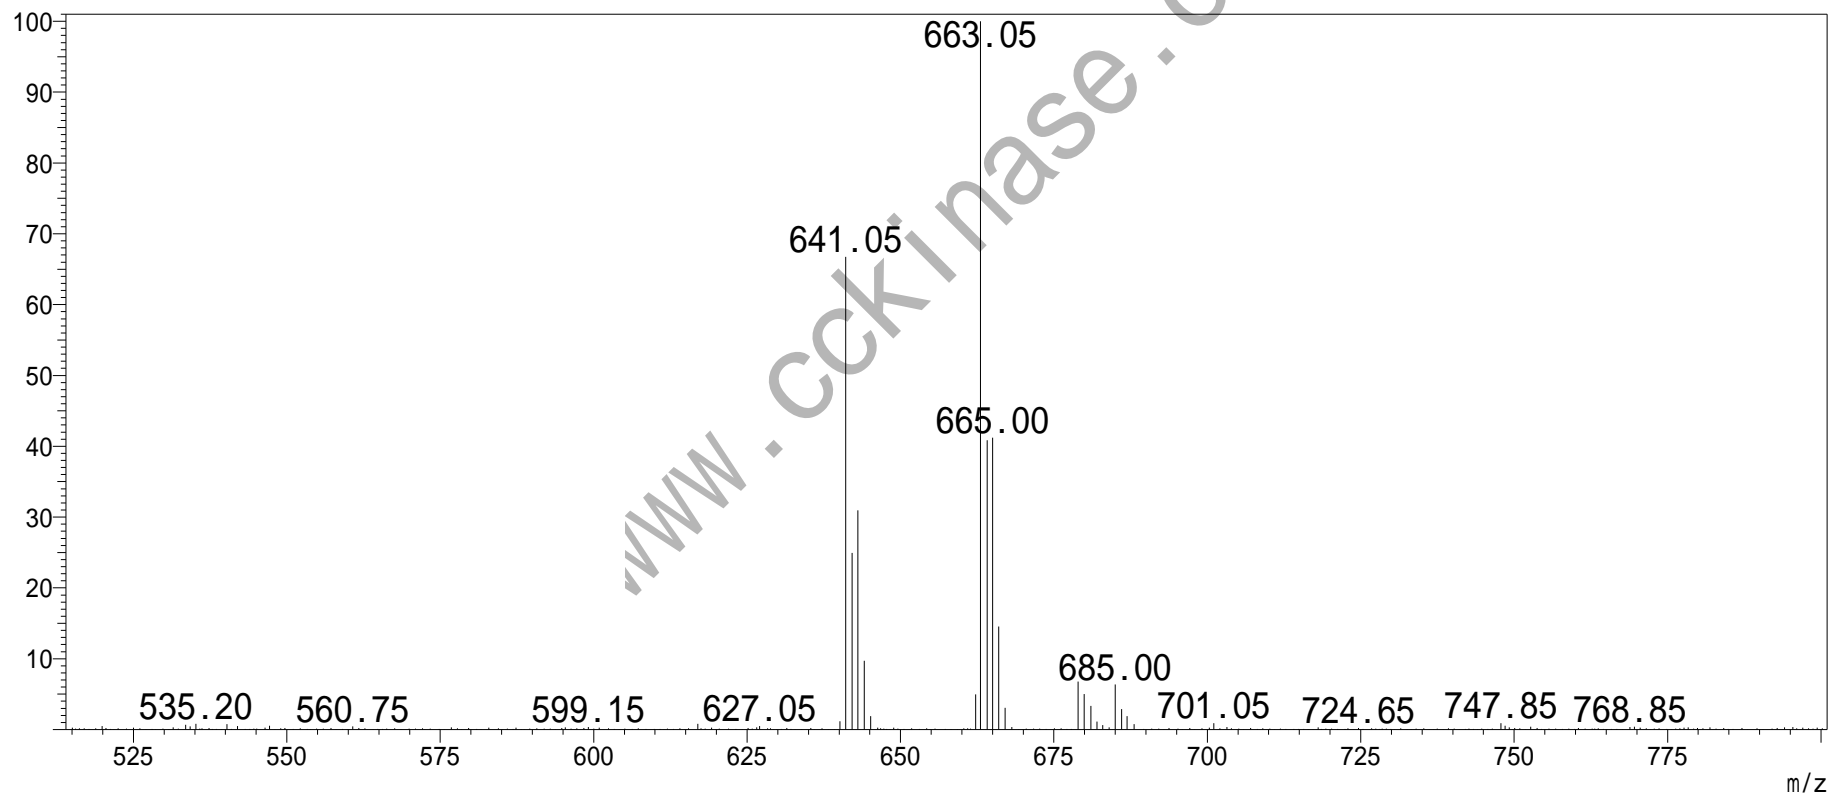
#: 1 保留时间: 2.633(扫描#: 159)

质谱: 单图 2.633(159) 基峰: 663.05(398609)
