==== Shimadzu LabSolutions Analysis Report ====

Sample Name : INCB057643 1820889-23-3
 Vial# : 1-15
 Date Acquired : 2019/7/12 15:33:01
 Date Processed : 2019/7/12 15:44:32
 Data Filename : D:\DATA\20190708\INCB057643 1820889-23-3.lcd
 Method Filename : C:\LabSolutions\Data\Project1\ESI.lcm
 Batch Filename : D:\DATA\20190708\20190708.lcb

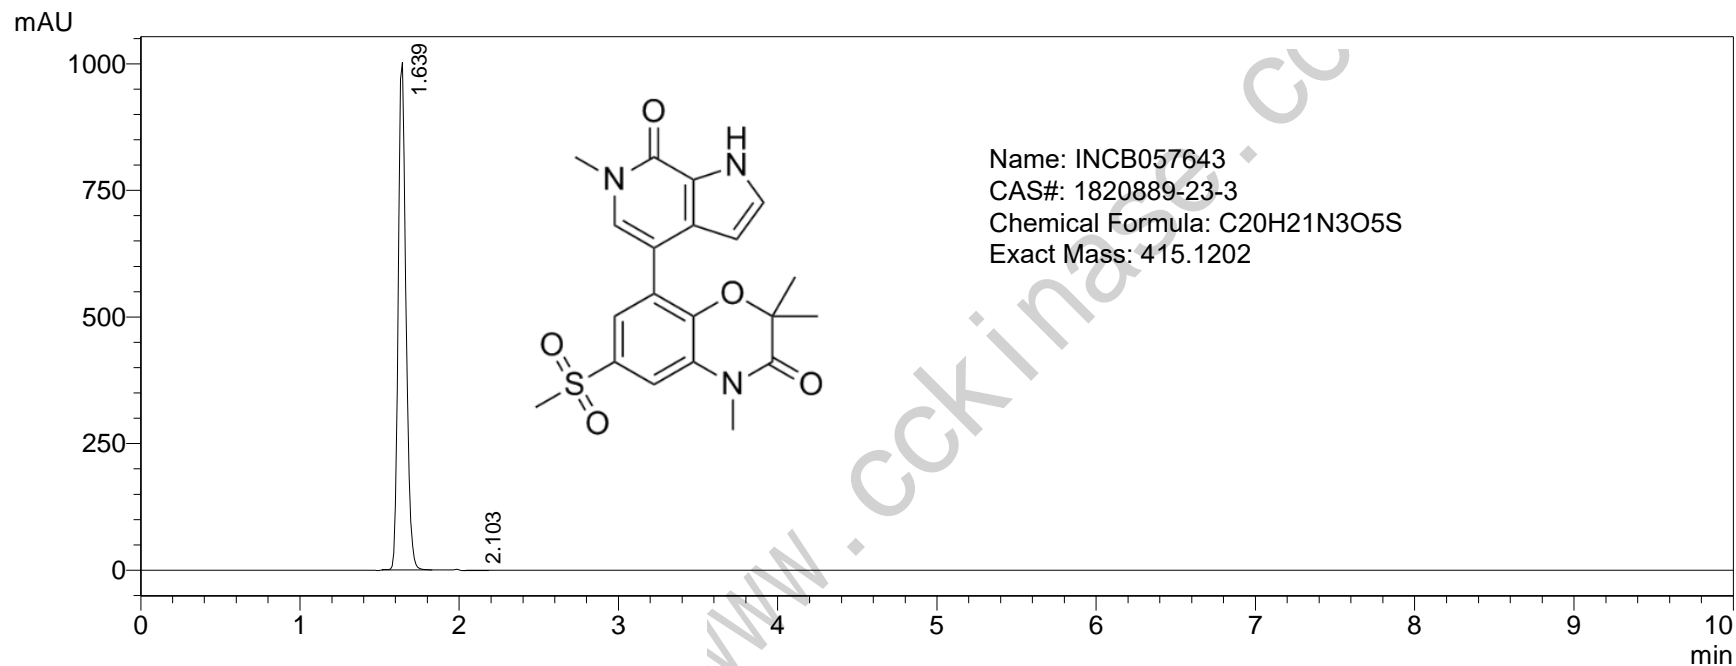
PDA Ch1 254nm

Peak#	Ret. Time	Height	Height%	Area	Area%	Name
1	1.639	1002314	99.918	3384615	99.816	
2	2.103	818	0.082	6250	0.184	
总计		1003132	100.000	3390864	100.000

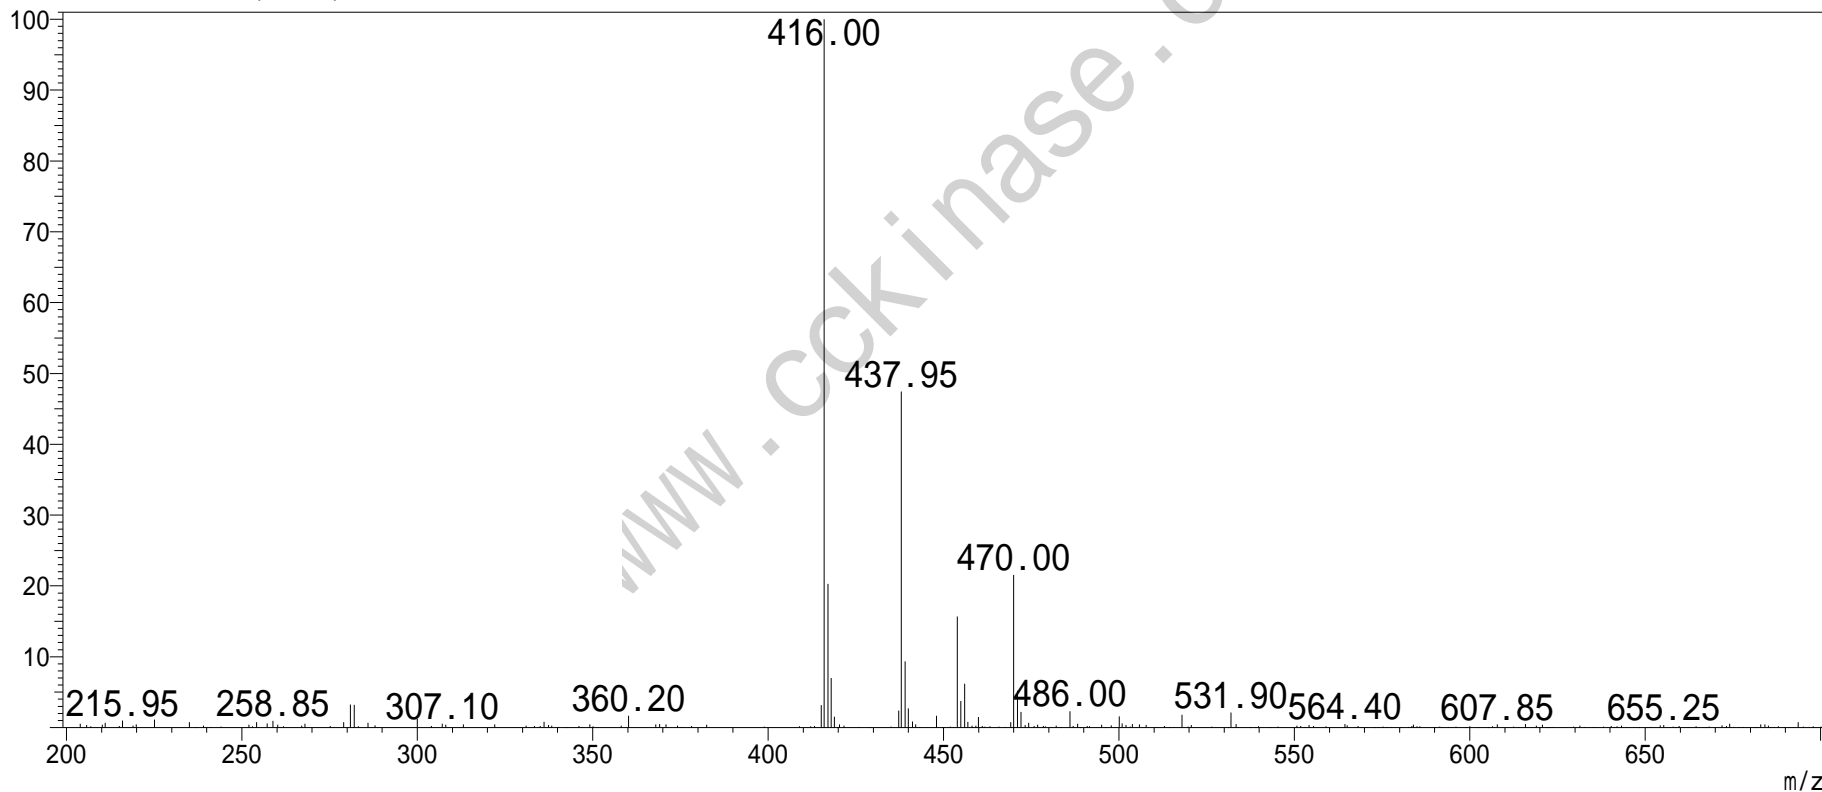
#: 1 保留时间: 1.833(扫描#: 111)

质谱: 单图 1.833(111) 基峰: 416.00(241909)

背景: 平均 0.833-1.267(51-77) 段 1 - 事件 1
